Ground Vibration Report

| Event Date | 2026/03/07 |
| Location | Phoenix 3865 Swan 6105 |

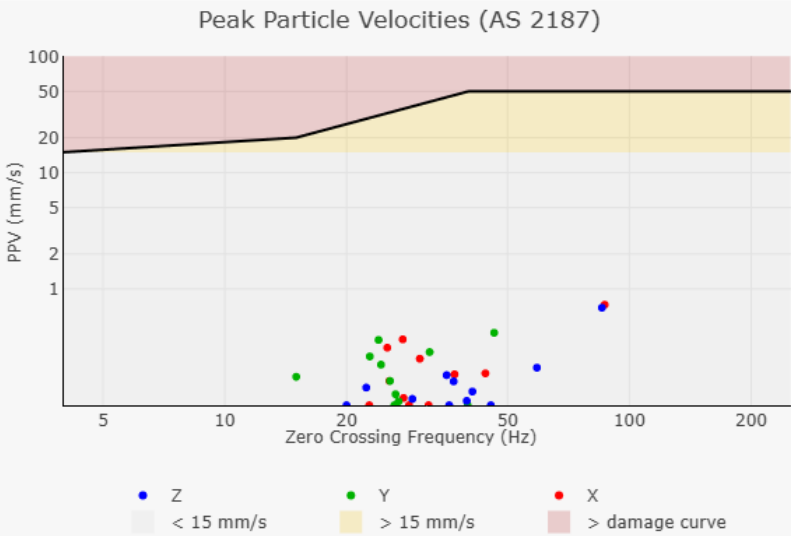
Per-component Peak Particle Velocities (PPV) vs. Zero Crossing Frequencies.  
Line indicates cosmetic damage guidelines  
(residential buildings, Fig. J4.4.2.1, AS 2187.2:2006).
