# Ground Vibration Report

| Event Time | 06:31:20 Australia/Melbourne |
| Location | Phoenix 3750 CRD DEC |
| Notes | Seismic event during development firing |

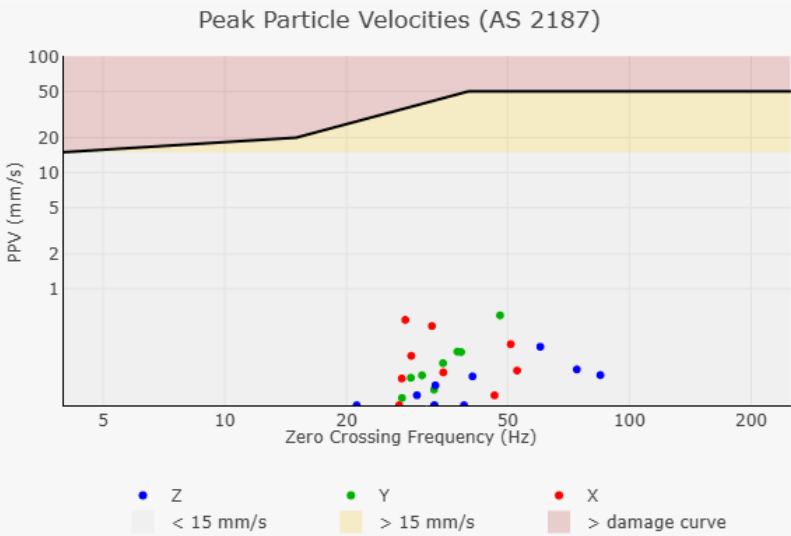
Per-component Peak Particle Velocities (PPV) vs. Zero Crossing Frequencies.  
Line indicates cosmetic damage guidelines  
(residential buildings, Fig. J4.4.2.1, AS 2187.2:2006).
