# Ground Vibration Report

| Event Date | 2026/03/10 |
| Location | Phoenix 3865 SWN 6105 |

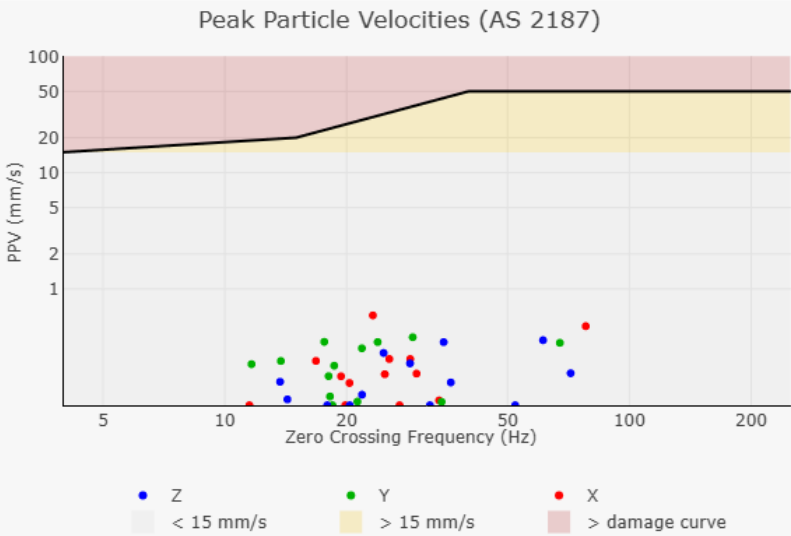
Per-component Peak Particle Velocities (PPV) vs. Zero Crossing Frequencies.  
Line indicates cosmetic damage guidelines  
(residential buildings, Fig. J4.4.2.1, AS 2187.2:2006).
