Ground Vibration Report

| Event Date | 2026/03/12 |
| Location | Phoenix 4105 Raptor 6415 |

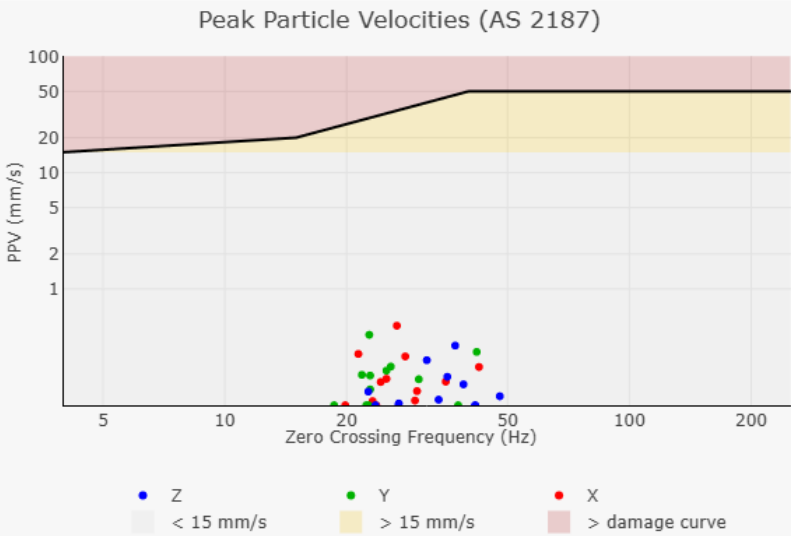
Per-component Peak Particle Velocities (PPV) vs. Zero Crossing Frequencies.  
Line indicates cosmetic damage guidelines  
(residential buildings, Fig. J4.4.2.1, AS 2187.2:2006).
