Ground Vibration Report

| Event Date | 2026/03/15 |
| Location | Phoenix 4105 RAP 6415 |

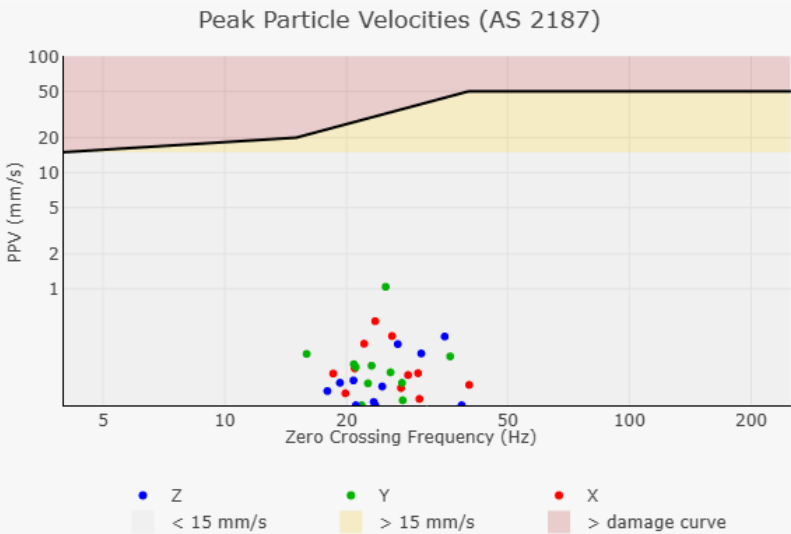
Per-component Peak Particle Velocities (PPV) vs. Zero Crossing Frequencies.  
Line indicates cosmetic damage guidelines  
(residential buildings, Fig. J4.4.2.1, AS 2187.2:2006).
