Ground Vibration Report

| Event Date | 2026/03/17 |
| Location | Harrier 4200 SP |

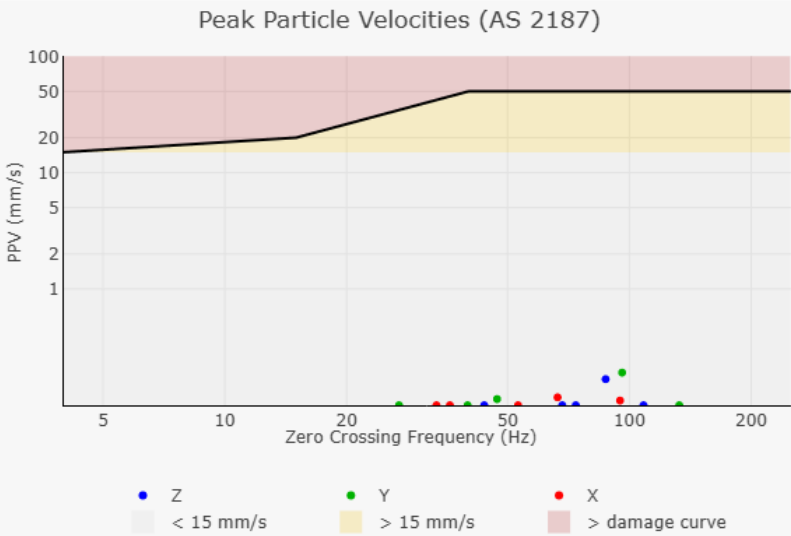
Per-component Peak Particle Velocities (PPV) vs. Zero Crossing Frequencies.  
Line indicates cosmetic damage guidelines  
(residential buildings, Fig. J4.4.2.1, AS 2187.2:2006).
