Ground Vibration Report

Summary

| Location | Phoenix 4010 CYG 6455 |

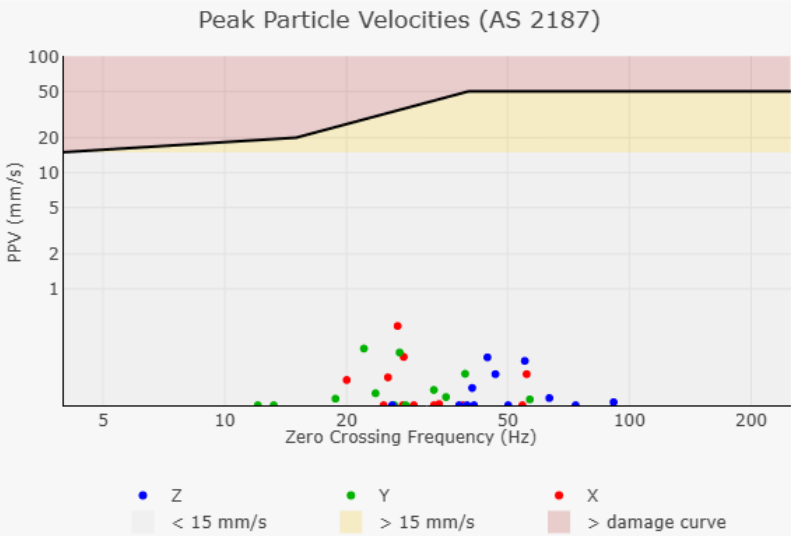
Per-component Peak Particle Velocities (PPV) vs. Zero Crossing Frequencies.  
Line indicates cosmetic damage guidelines  
(residential buildings, Fig. J4.4.2.1, AS 2187.2:2006).
