Ground Vibration Report

| Event Date | 2026/03/21 |
| Location | Harrier 4310 NFW 4970 |

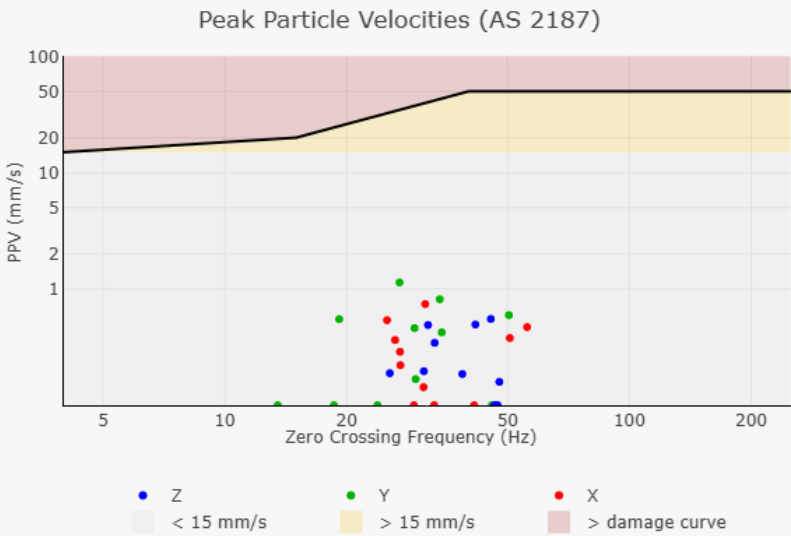
Per-component Peak Particle Velocities (PPV) vs. Zero Crossing Frequencies.  
Line indicates cosmetic damage guidelines  
(residential buildings, Fig. J4.4.2.1, AS 2187.2:2006).
