Ground Vibration Report

Summary

| Location | Phoenix 3765 LPH 5935 |

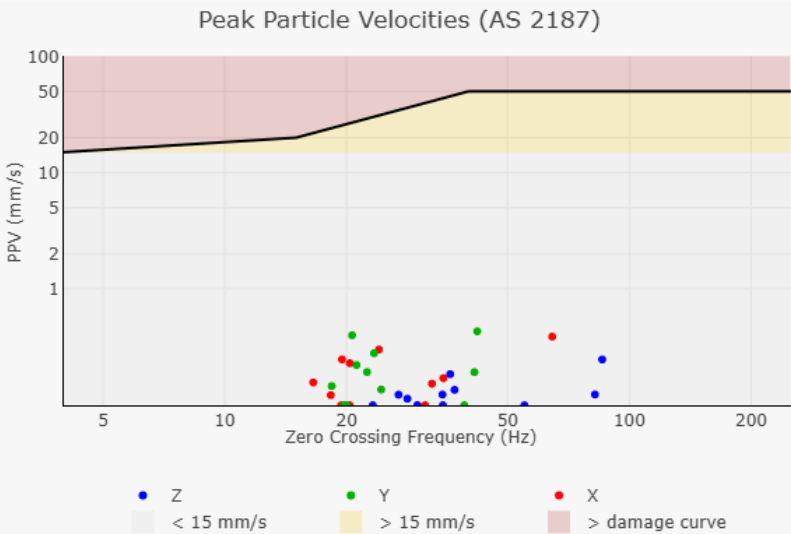
Per-component Peak Particle Velocities (PPV) vs. Zero Crossing Frequencies.  
Line indicates cosmetic damage guidelines  
(residential buildings, Fig. J4.4.2.1, AS 2187.2:2006).
