# Ground Vibration Report

| Event Type | Production Blast |
| Event Date | 2026/04/07 |
| Location | Phoenix 3765 LPH 5935 |

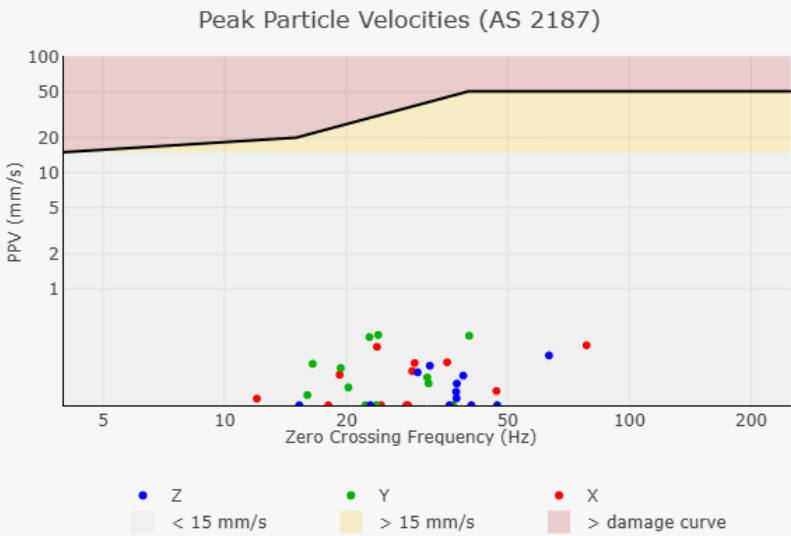
Per-component Peak Particle Velocities (PPV) vs. Zero Crossing Frequencies.  
Line indicates cosmetic damage guidelines  
(residential buildings, Fig. J4.4.2.1, AS 2187.2:2006).
