Ground Vibration Report

| Event Type | Production Blast |
| Event Date | 2026/04/14 |
| Location | Phoenix 3840 LPH 6085 |

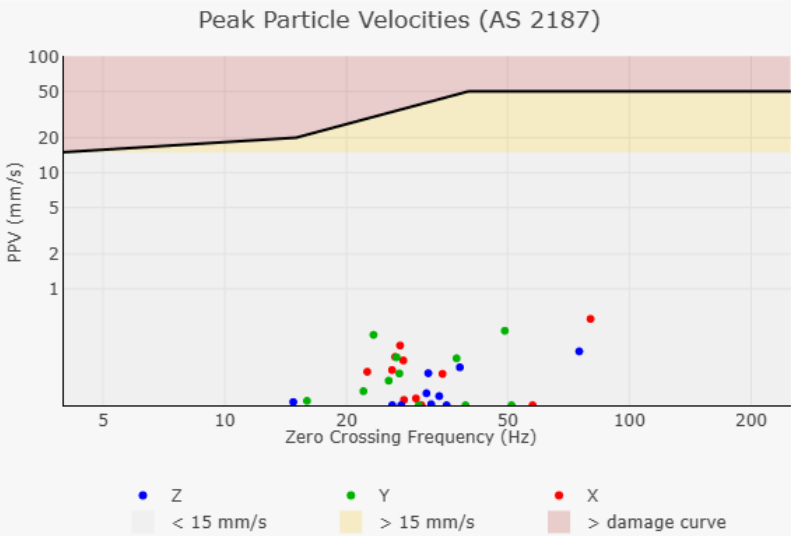
Per-component Peak Particle Velocities (PPV) vs. Zero Crossing Frequencies.  
Line indicates cosmetic damage guidelines  
(residential buildings, Fig. J4.4.2.1, AS 2187.2:2006).
