Ground Vibration Report

| Event Date | 2026/04/19 |
| Location | Phoenix 3690 ACC |

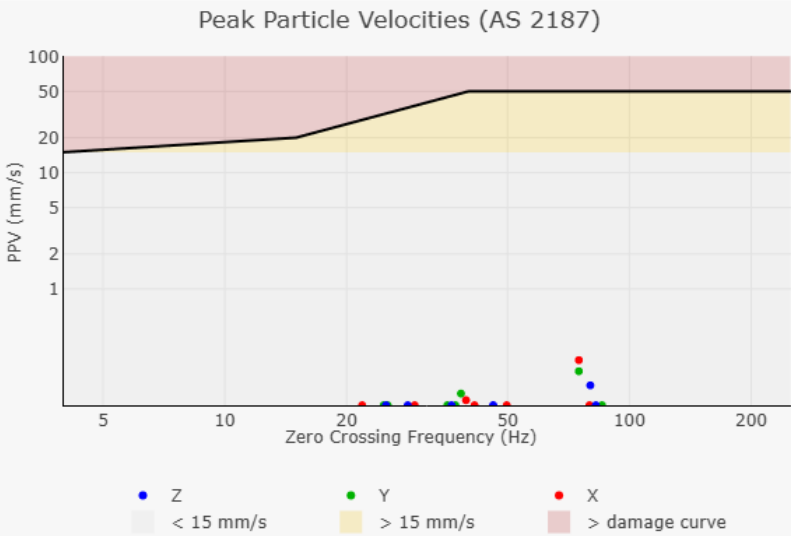
Per-component Peak Particle Velocities (PPV) vs. Zero Crossing Frequencies.  
Line indicates cosmetic damage guidelines  
(residential buildings, Fig. J4.4.2.1, AS 2187.2:2006).
