# Ground Vibration Report

| Event Date | 2026/04/19 |
| Location | Robbins Hill 4560 ORD 2455 |

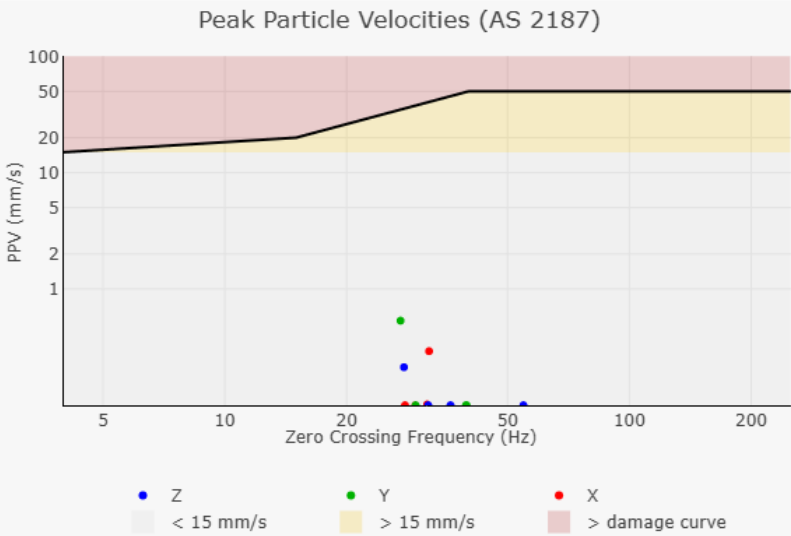
Per-component Peak Particle Velocities (PPV) vs. Zero Crossing Frequencies.  
Line indicates cosmetic damage guidelines  
(residential buildings, Fig. J4.4.2.1, AS 2187.2:2006).
