Ground Vibration Report

Summary

| Location | Phoenix 4010 CYG 6395 |

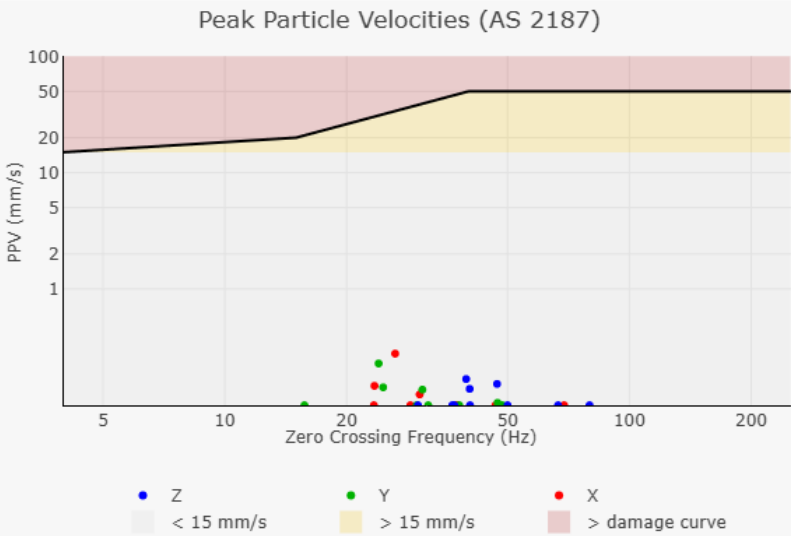
Per-component Peak Particle Velocities (PPV) vs. Zero Crossing Frequencies.  
Line indicates cosmetic damage guidelines  
(residential buildings, Fig. J4.4.2.1, AS 2187.2:2006).
