Ground Vibration Report

| Event Type | Production Blast |
| Event Date | 2026/04/28 |
| Location | Phoenix 3790 LPH 6030 |

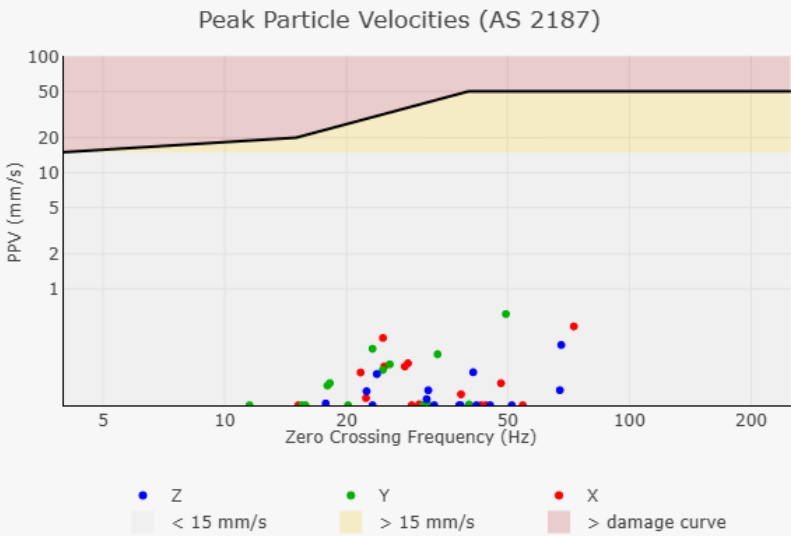
Per-component Peak Particle Velocities (PPV) vs. Zero Crossing Frequencies.  
Line indicates cosmetic damage guidelines  
(residential buildings, Fig. J4.4.2.1, AS 2187.2:2006).
