Ground Vibration Report

| Event Date | 2026/04/28 |
| Location | Phoenix_4010_CYG_6395 |

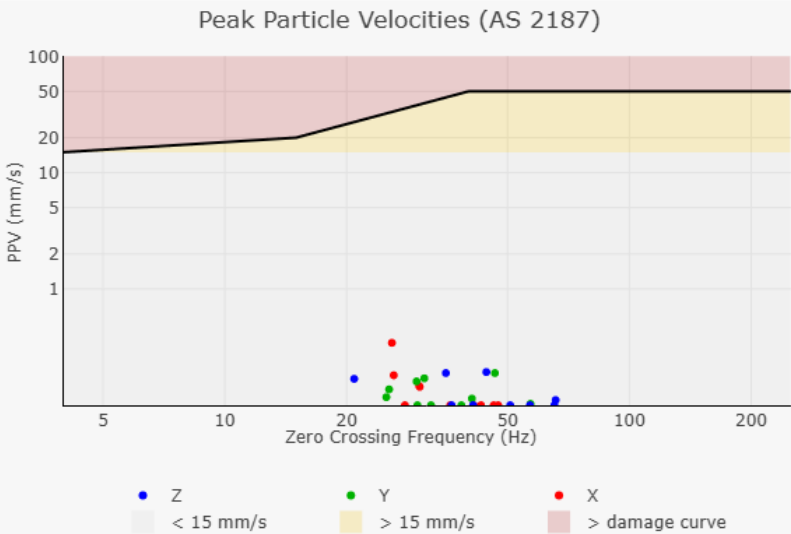
Per-component Peak Particle Velocities (PPV) vs. Zero Crossing Frequencies.  
Line indicates cosmetic damage guidelines  
(residential buildings, Fig. J4.4.2.1, AS 2187.2:2006).
