Ground Vibration Report

Summary

| Location | Phoenix 3670 CRD DEC |

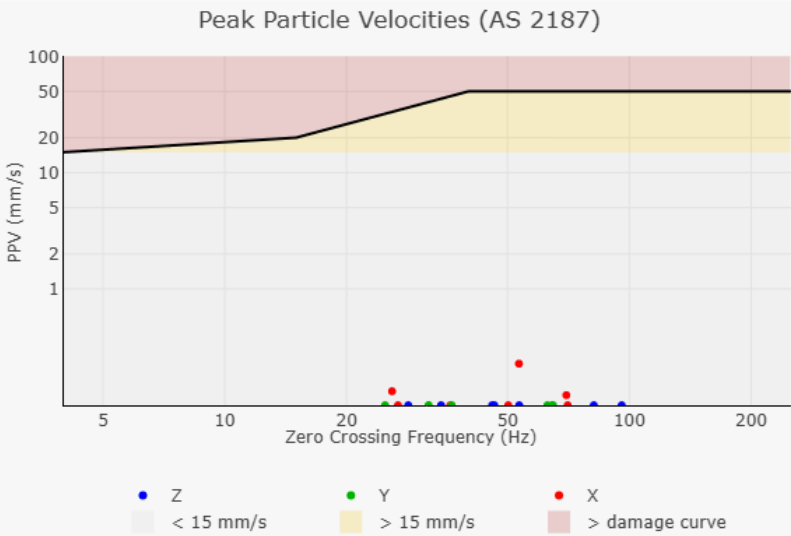
Per-component Peak Particle Velocities (PPV) vs. Zero Crossing Frequencies.  
Line indicates cosmetic damage guidelines  
(residential buildings, Fig. J4.4.2.1, AS 2187.2:2006).
