Ground Vibration Report

| Location | Phoenix 3790 LPH 6030 |

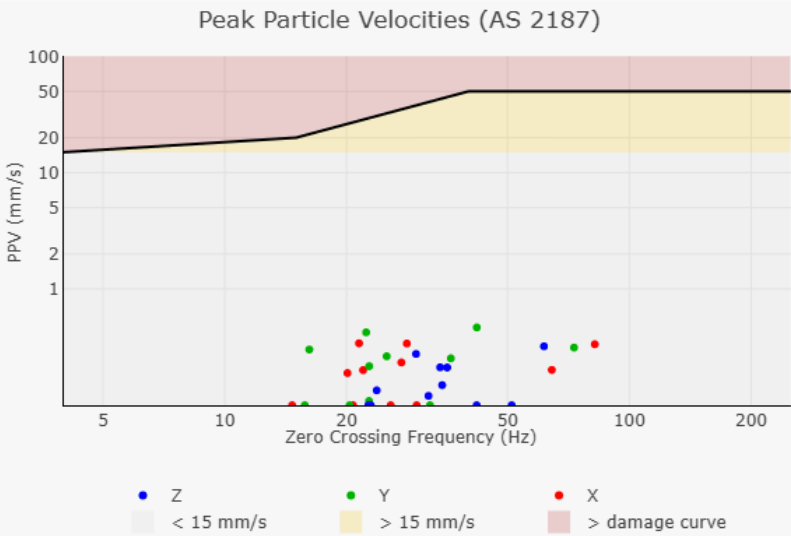
Per-component Peak Particle Velocities (PPV) vs. Zero Crossing Frequencies.  
Line indicates cosmetic damage guidelines  
(residential buildings, Fig. J4.4.2.1, AS 2187.2:2006).
