# Ground Vibration Report

| Location | Phoenix 3740 LPH 5840 |

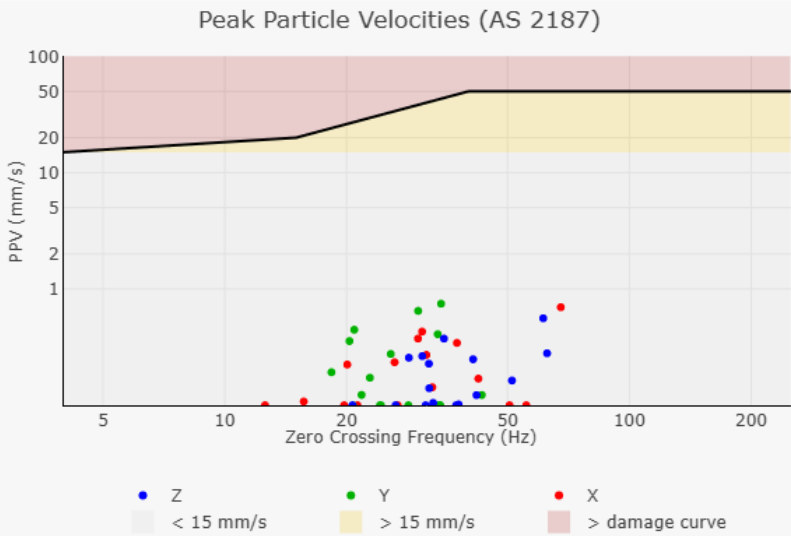
Per-component Peak Particle Velocities (PPV) vs. Zero Crossing Frequencies.  
Line indicates cosmetic damage guidelines  
(residential buildings, Fig. J4.4.2.1, AS 2187.2:2006).
