Ground Vibration Report

Summary

| Location | Phoenix 3695-3710 RAR |

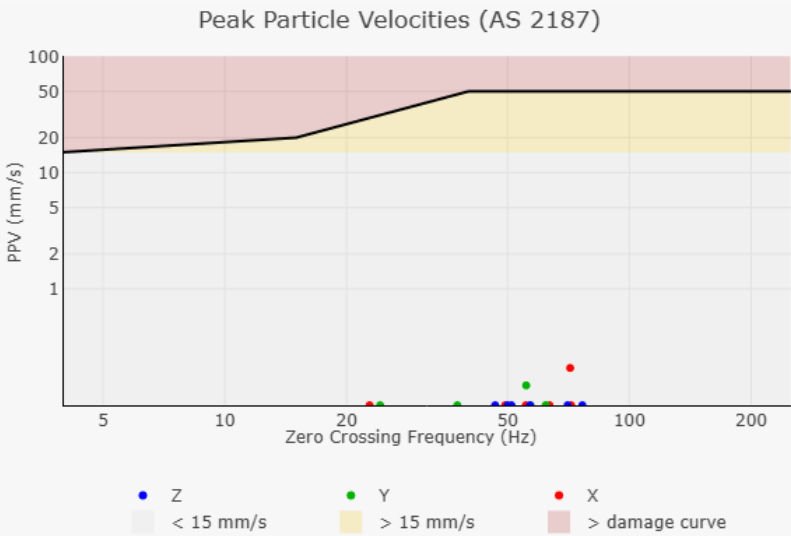
Per-component Peak Particle Velocities (PPV) vs. Zero Crossing Frequencies.  
Line indicates cosmetic damage guidelines  
(residential buildings, Fig. J4.4.2.1, AS 2187.2:2006).
