Ground Vibration Report

| Event Date | 2026/05/09 |
| Location | Phoenix 3740 LPH 5840 |

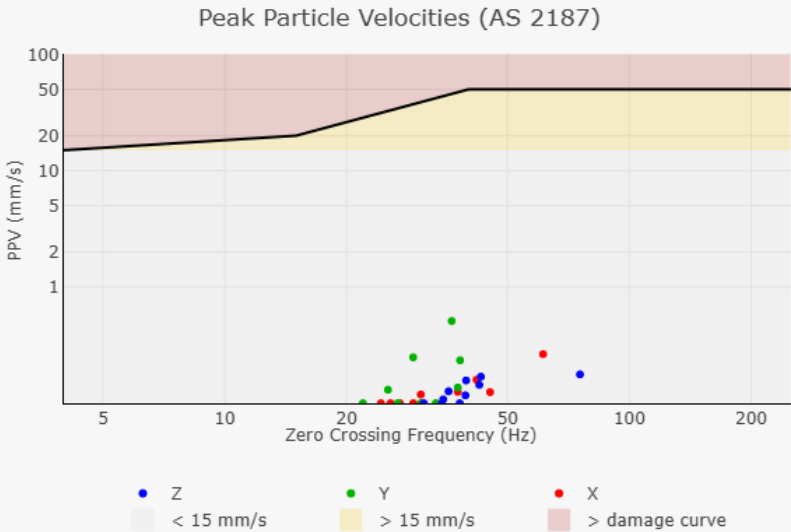
Per-component Peak Particle Velocities (PPV) vs. Zero Crossing Frequencies.  
Line indicates cosmetic damage guidelines  
(residential buildings, Fig. J4.4.2.1, AS 2187.2:2006).
