# Ground Vibration Report

| Event Type | Production Blast |
| Event Date | 2026/05/15 |
| Location | Phoenix 3715 LPH 5765 |

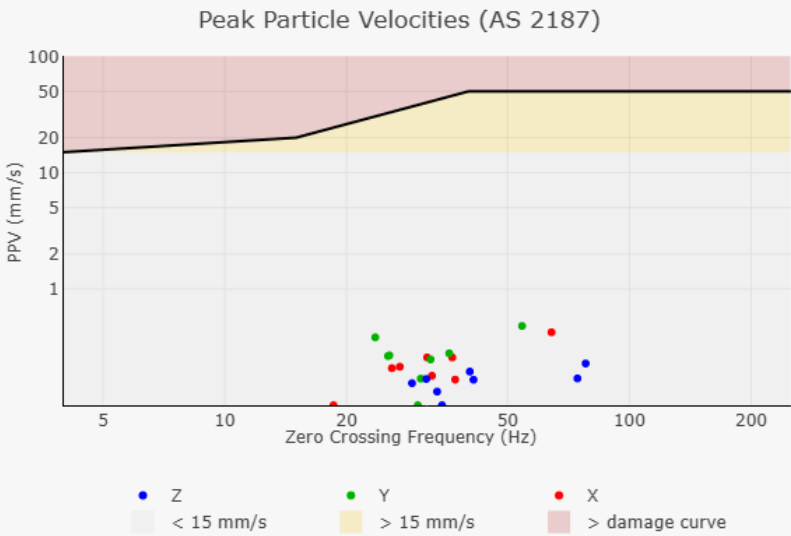
Per-component Peak Particle Velocities (PPV) vs. Zero Crossing Frequencies.  
Line indicates cosmetic damage guidelines  
(residential buildings, Fig. J4.4.2.1, AS 2187.2:2006).
