Ground Vibration Report

| Event Date | 2026/05/17 |
| Location | Phoenix 3715 LPH 5765 |

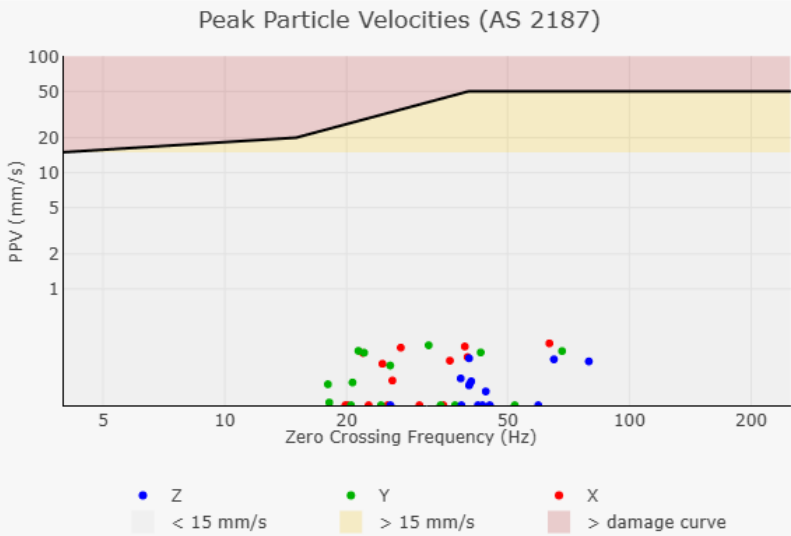
Per-component Peak Particle Velocities (PPV) vs. Zero Crossing Frequencies. Line indicates cosmetic damage guidelines (residential buildings, Fig. J4.4.2.1, AS 2187.2:2006).
