Ground Vibration Report

| Event Date | 2026/05/22 |
| Location | Phoenix 3865 Swan 6120 |

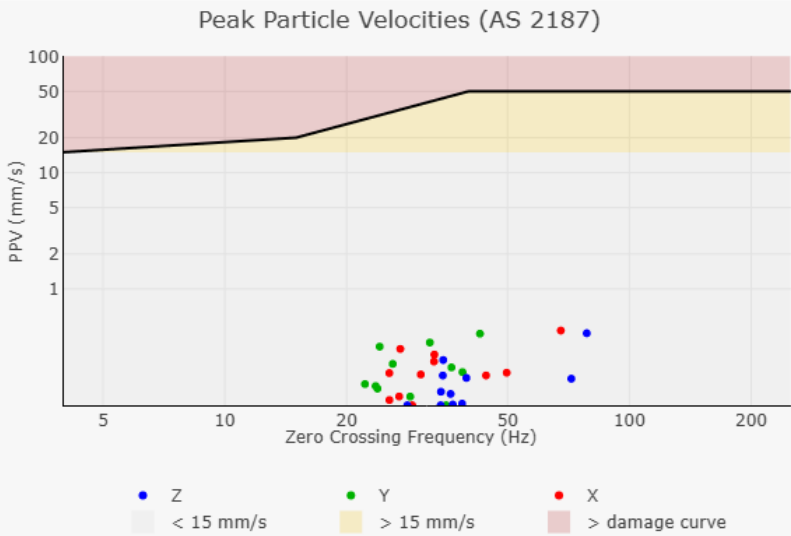
Per-component Peak Particle Velocities (PPV) vs. Zero Crossing Frequencies.  
Line indicates cosmetic damage guidelines  
(residential buildings, Fig. J4.4.2.1, AS 2187.2:2006).
