# Ground Vibration Report

| Event Date | 2026/05/28 |
| Location | Robbins Hill 4580 FWD 2475 |

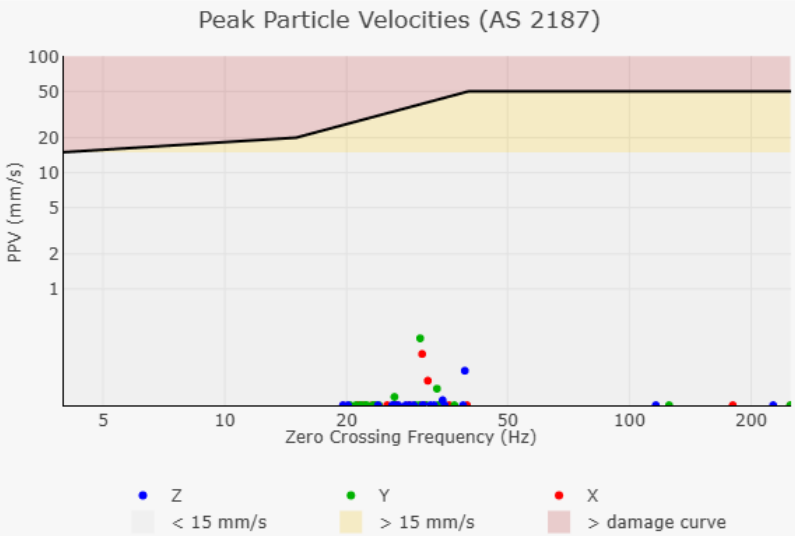
Per-component Peak Particle Velocities (PPV) vs. Zero Crossing Frequencies.  
Line indicates cosmetic damage guidelines  
(residential buildings, Fig. J4.4.2.1, AS 2187.2:2006).
