Ground Vibration Report

| Event Date | 2026/05/30 |
| Location | Phoenix 3865 SWN 6120 |

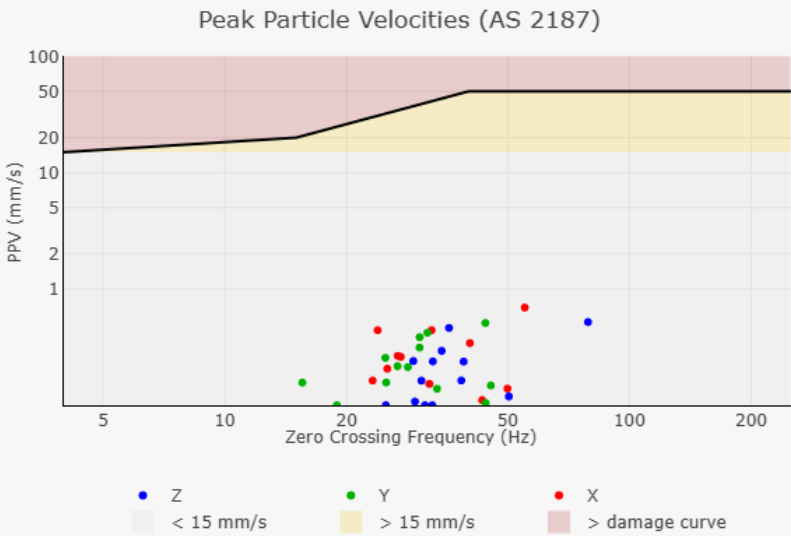
Per-component Peak Particle Velocities (PPV) vs. Zero Crossing Frequencies. Line indicates cosmetic damage guidelines (residential buildings, Fig. J4.4.2.1, AS 2187.2:2006).
