Ground Vibration Report

| Event Type | Development Blast |
| Event Date | 2026/06/03 |
| Location | Harrier 4240 RAW W |

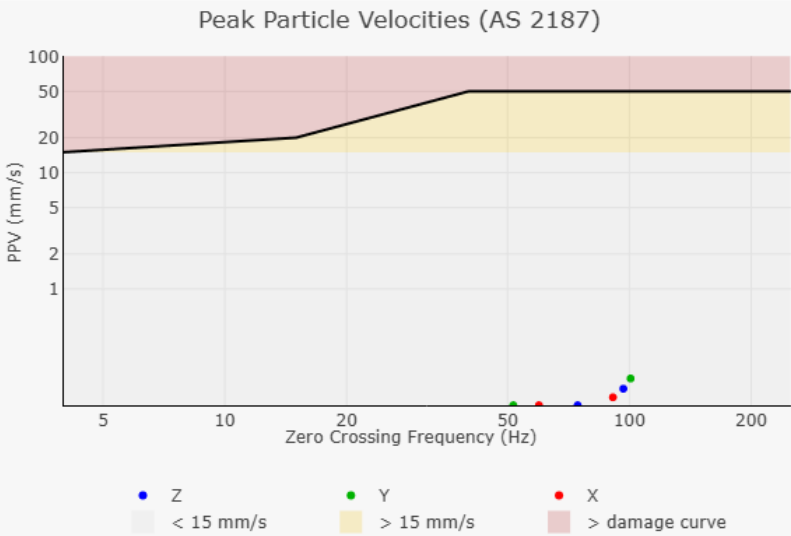
Per-component Peak Particle Velocities (PPV) vs. Zero Crossing Frequencies.  
Line indicates cosmetic damage guidelines  
(residential buildings, Fig. J4.4.2.1, AS 2187.2:2006).
