Ground Vibration Report

| Event Date | 2026/06/03 |
| Location | Phoenix 3815 LPH 6065 |

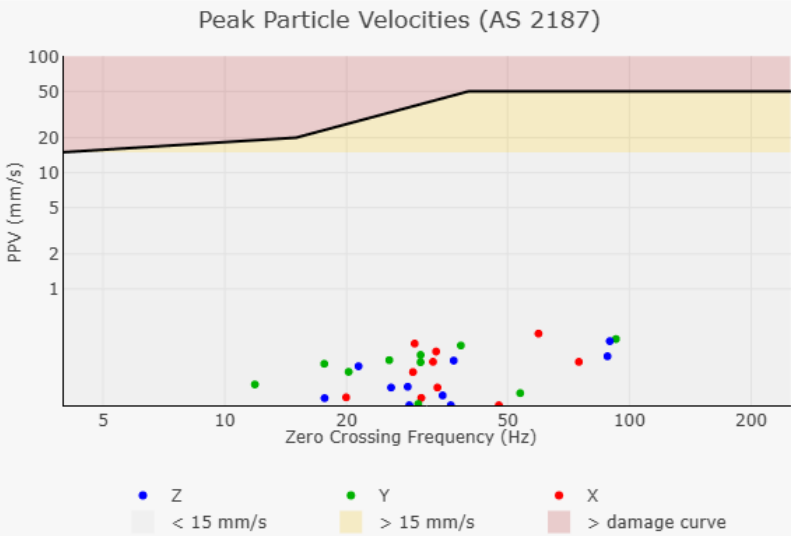
Per-component Peak Particle Velocities (PPV) vs. Zero Crossing Frequencies. Line indicates cosmetic damage guidelines (residential buildings, Fig. J4.4.2.1, AS 2187.2:2006).
