Ground Vibration Report

| Location | Phoenix 3880 CYG 6450 |

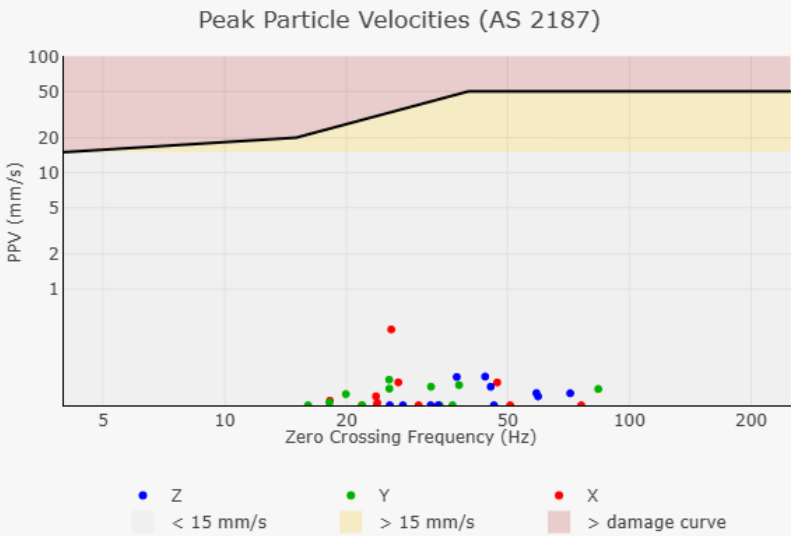
Per-component Peak Particle Velocities (PPV) vs. Zero Crossing Frequencies.  
Line indicates cosmetic damage guidelines  
(residential buildings, Fig. J4.4.2.1, AS 2187.2:2006).
