# Ground Vibration Report

| Event Date | 2026/06/08 |
| Location | Phoenix 3990 CYG 6450 |

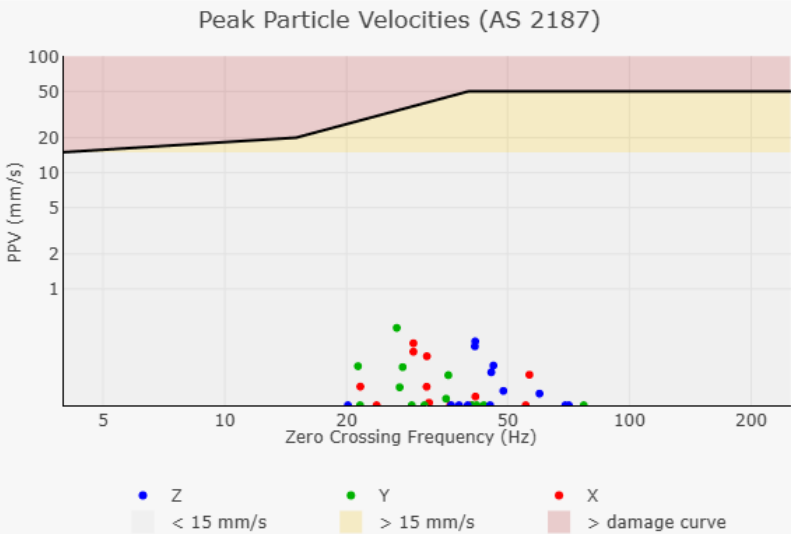
Per-component Peak Particle Velocities (PPV) vs. Zero Crossing Frequencies.  
Line indicates cosmetic damage guidelines  
(residential buildings, Fig. J4.4.2.1, AS 2187.2:2006).
