Ground Vibration Report

Summary

| Location | Harrier 4330 NFW 4965 |

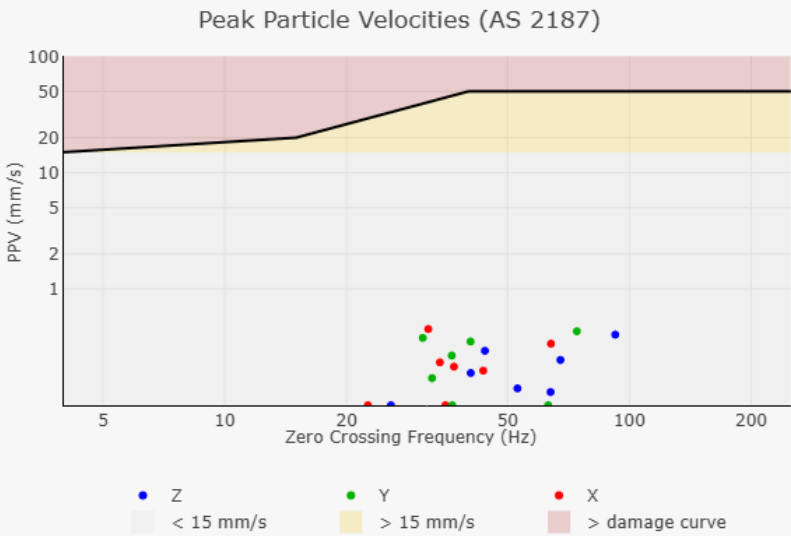
Per-component Peak Particle Velocities (PPV) vs. Zero Crossing Frequencies.  
Line indicates cosmetic damage guidelines  
(residential buildings, Fig. J4.4.2.1, AS 2187.2:2006).
