# Ground Vibration Report

| Event Type | Production Blast |
| Event Date | 2026/06/12 |
| Location | Phoenix 3990 Cygnet 6450 |

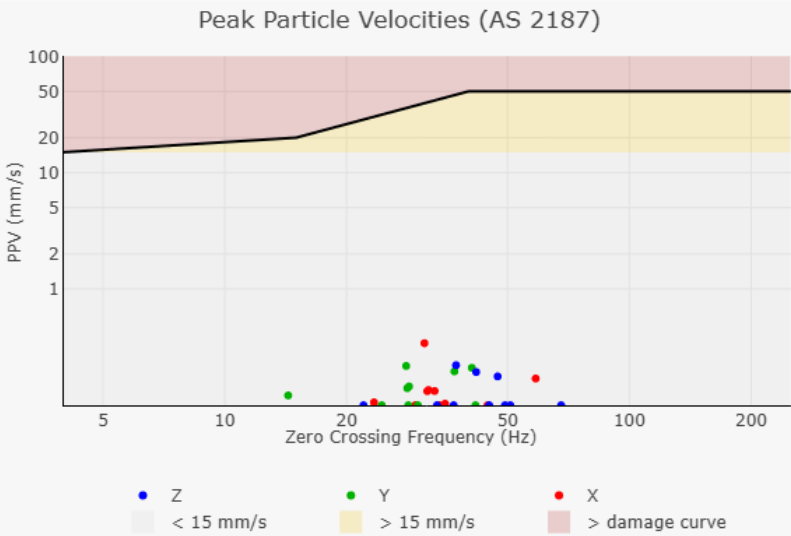
Per-component Peak Particle Velocities (PPV) vs. Zero Crossing Frequencies.  
Line indicates cosmetic damage guidelines  
(residential buildings, Fig. J4.4.2.1, AS 2187.2:2006).
