# Ground Vibration Report

| Event Date | 2026/06/13 |
| Location | Phoenix 3815 LPH 6065 |

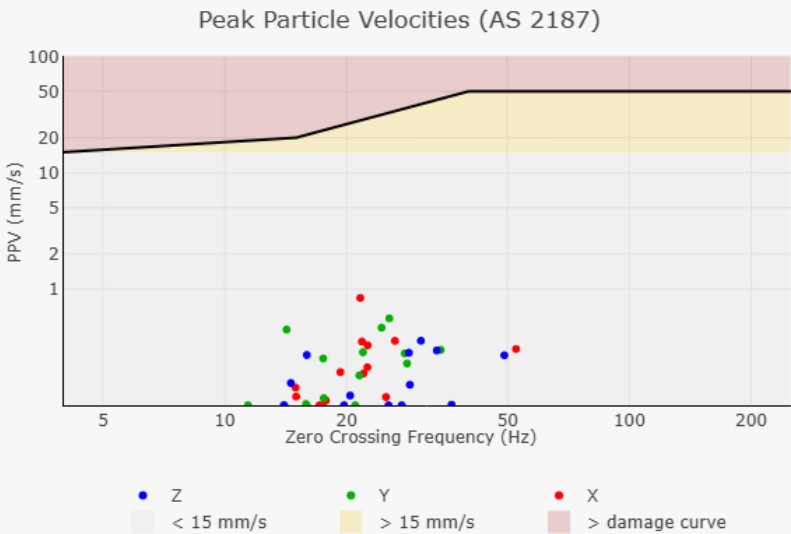
Per-component Peak Particle Velocities (PPV) vs. Zero Crossing Frequencies.  
Line indicates cosmetic damage guidelines  
(residential buildings, Fig. J4.4.2.1, AS 2187.2:2006).
