Ground Vibration Report

| Event Time | 06:30:05 Australia/Melbourne |
| Location | Phoenix 3765 LPH 5980 |

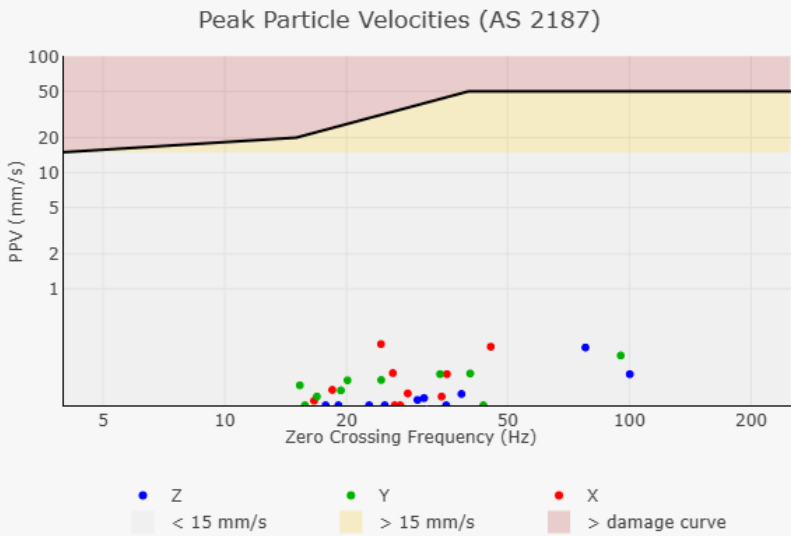
Per-component Peak Particle Velocities (PPV) vs. Zero Crossing Frequencies.  
Line indicates cosmetic damage guidelines  
(residential buildings, Fig. J4.4.2.1, AS 2187.2:2006).
