Ground Vibration Report

| Event Time | 18:39:52 Australia/Melbourne |
| Location | Phoenix 4105 RAP 6420 |

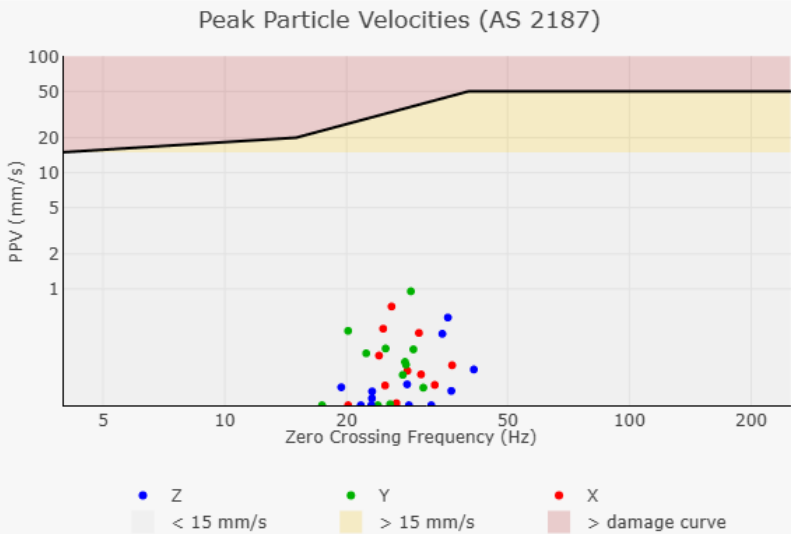
Per-component Peak Particle Velocities (PPV) vs. Zero Crossing Frequencies.  
Line indicates cosmetic damage guidelines  
(residential buildings, Fig. J4.4.2.1, AS 2187.2:2006).
