Ground Vibration Report

Summary

| Location | Phoenix 4010 CYG 6380 |

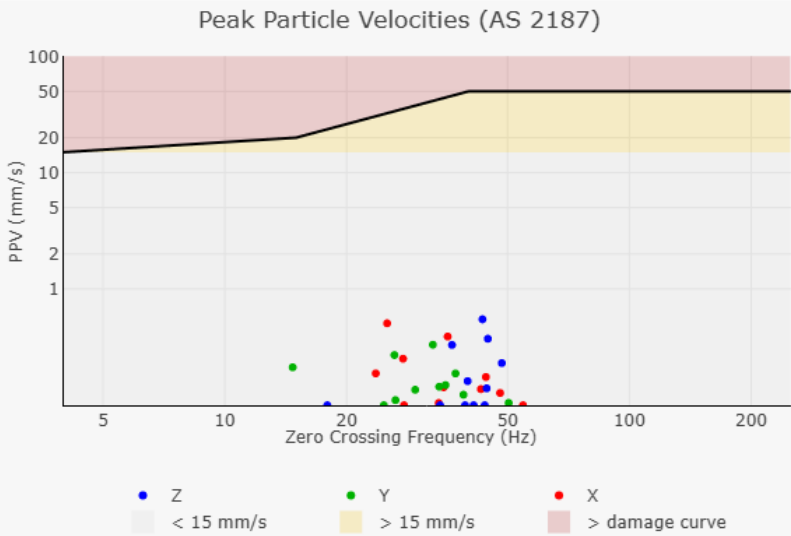
Per-component Peak Particle Velocities (PPV) vs. Zero Crossing Frequencies. Line indicates cosmetic damage guidelines (residential buildings, Fig. J4.4.2.1, AS 2187.2:2006).
