Ground Vibration Report

| Event Type | Development Blast |
| Location | Harrier 4220 ACC |

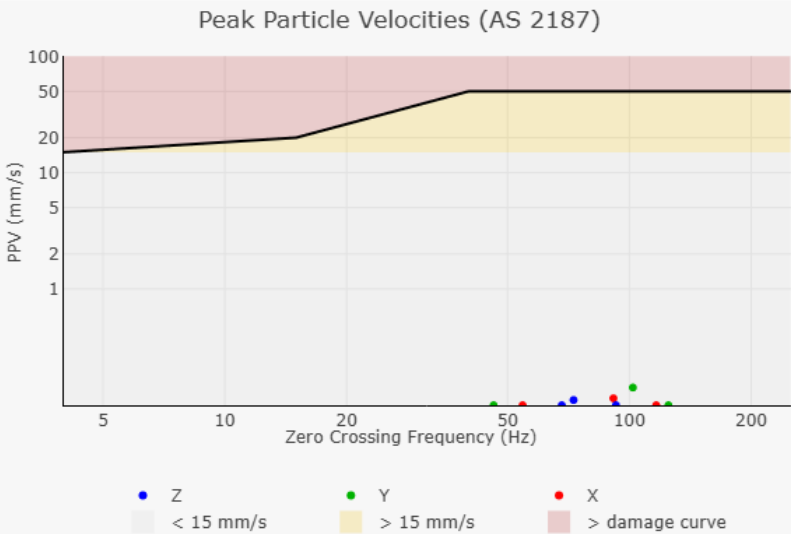
Per-component Peak Particle Velocities (PPV) vs. Zero Crossing Frequencies.  
Line indicates cosmetic damage guidelines  
(residential buildings, Fig. J4.4.2.1, AS 2187.2:2006).
