Ground Vibration Report

| Event Date | 2026/06/26 |
| Location | Phoenix 4010 CYG A 6380 |

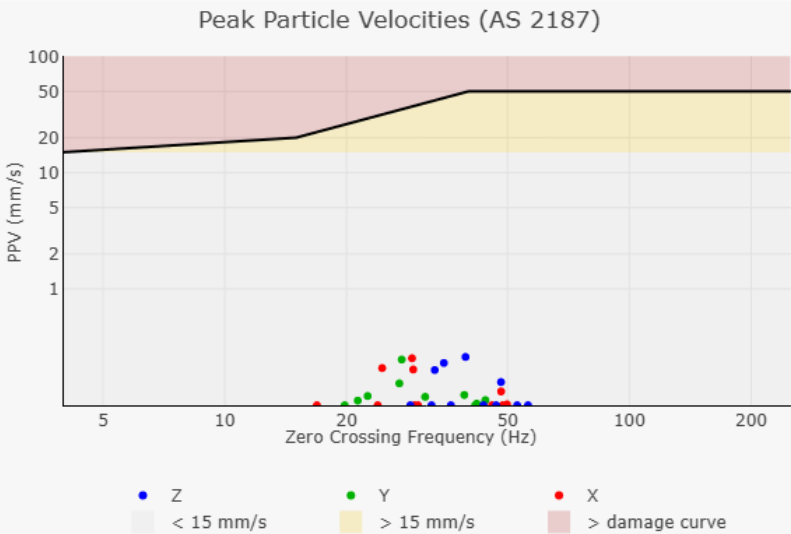
Per-component Peak Particle Velocities (PPV) vs. Zero Crossing Frequencies.  
Line indicates cosmetic damage guidelines  
(residential buildings, Fig. J4.4.2.1, AS 2187.2:2006).
