Ground Vibration Report

| Event Type | Development Blast |
| Location | Harrier 4200 Mono |

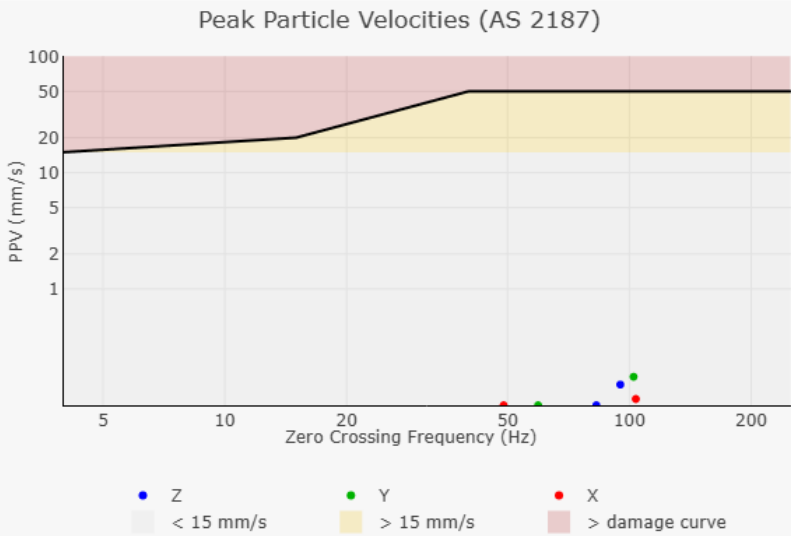
Per-component Peak Particle Velocities (PPV) vs. Zero Crossing Frequencies.  
Line indicates cosmetic damage guidelines  
(residential buildings, Fig. J4.4.2.1, AS 2187.2:2006).
