Ground Vibration Report

Summary

| Location | Phoenix 4105 RAP 6415 |

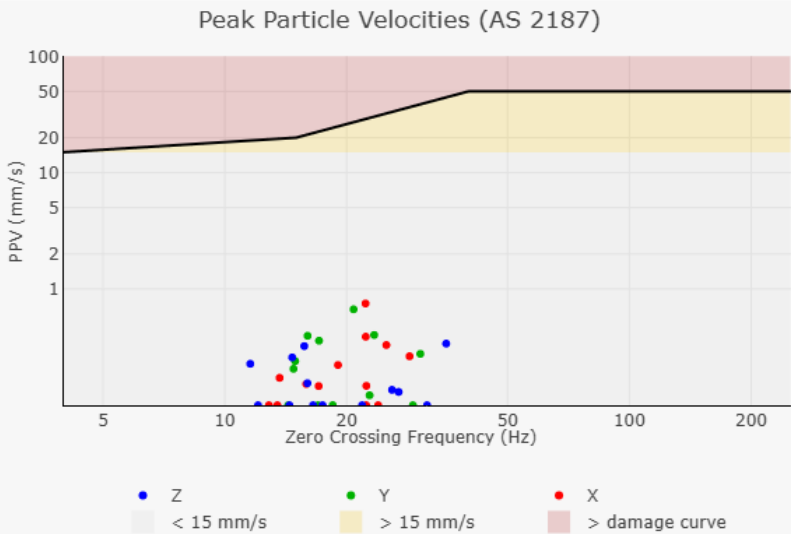
Per-component Peak Particle Velocities (PPV) vs. Zero Crossing Frequencies.  
Line indicates cosmetic damage guidelines  
(residential buildings, Fig. J4.4.2.1, AS 2187.2:2006).
