Ground Vibration Report

| Location | Phoenix 3910 RTH 6020 |

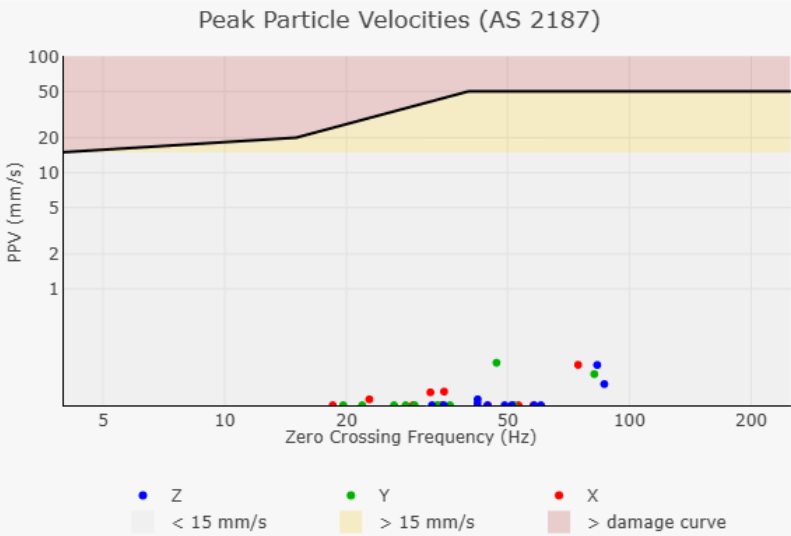
Per-component Peak Particle Velocities (PPV) vs. Zero Crossing Frequencies.  
Line indicates cosmetic damage guidelines  
(residential buildings, Fig. J4.4.2.1, AS 2187.2:2006).
