# Ground Vibration Report

| Event Date | 2026/07/05 |
| Location | Harrier 4330 NFW 4965 |

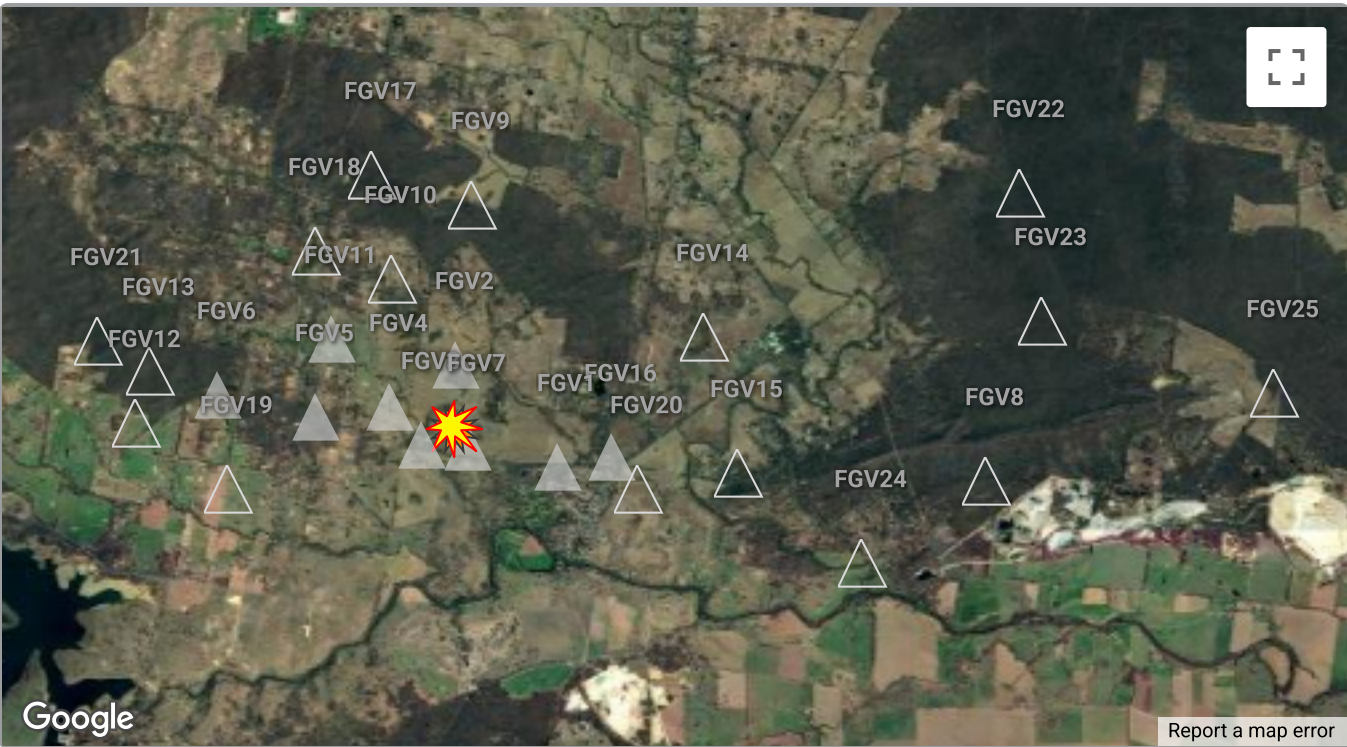
| Distance Below Surface | ~670 m |

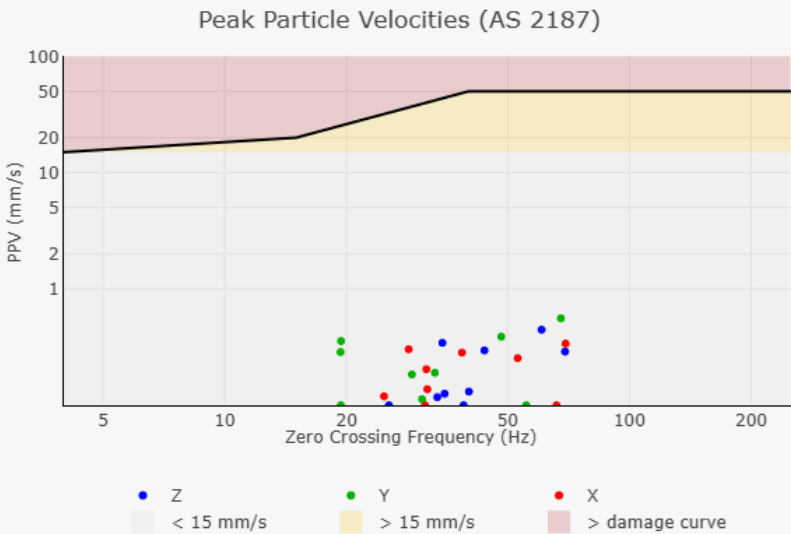
Per-component Peak Particle Velocities (PPV) vs. Zero Crossing Frequencies.  
Line indicates cosmetic damage guidelines  
(residential buildings, Fig. J4.4.2.1, AS 2187.2:2006).
