Ground Vibration Report

Summary

| Location | Harrier 4200 MNC |

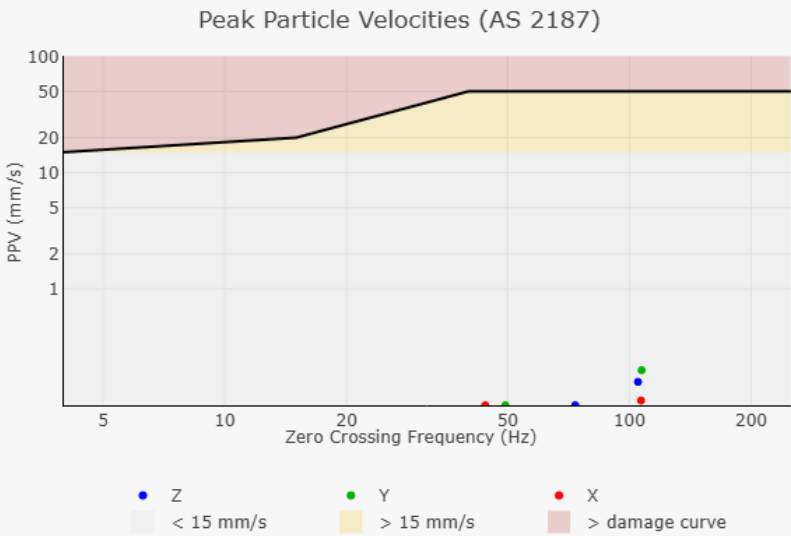
Per-component Peak Particle Velocities (PPV) vs. Zero Crossing Frequencies.  
Line indicates cosmetic damage guidelines  
(residential buildings, Fig. J4.4.2.1, AS 2187.2:2006).
