# Ground Vibration Report

| Event Type | Production Blast |
| Location | Phoenix 3840 LPH 6100 |

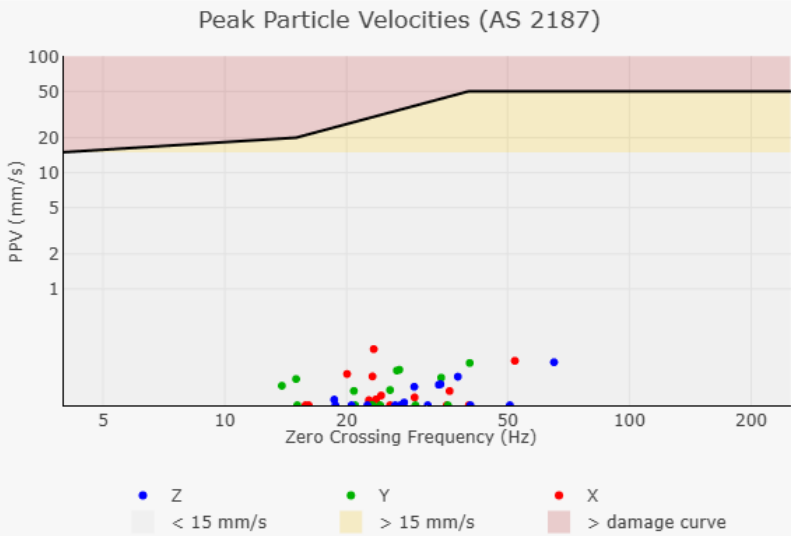
Per-component Peak Particle Velocities (PPV) vs. Zero Crossing Frequencies.  
Line indicates cosmetic damage guidelines  
(residential buildings, Fig. J4.4.2.1, AS 2187.2:2006).
