Ground Vibration Report

| Event Date | 2026/07/13 |
| Location | Phoenix 3840 LPH 6100 |

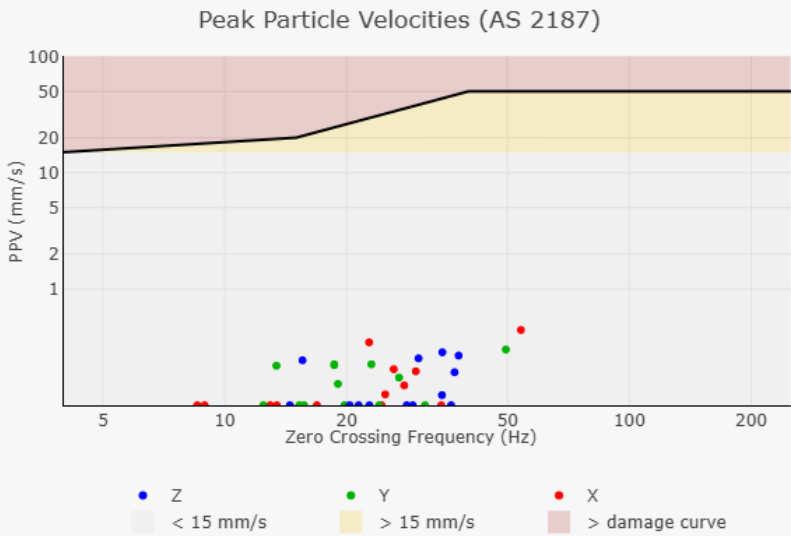
Per-component Peak Particle Velocities (PPV) vs. Zero Crossing Frequencies.  
Line indicates cosmetic damage guidelines  
(residential buildings, Fig. J4.4.2.1, AS 2187.2:2006).
