Ground Vibration Report

| Event Type | Production Blast |
| Event Date | 2026/07/14 |
| Location | Phoenix 3740 LPH 5850 |

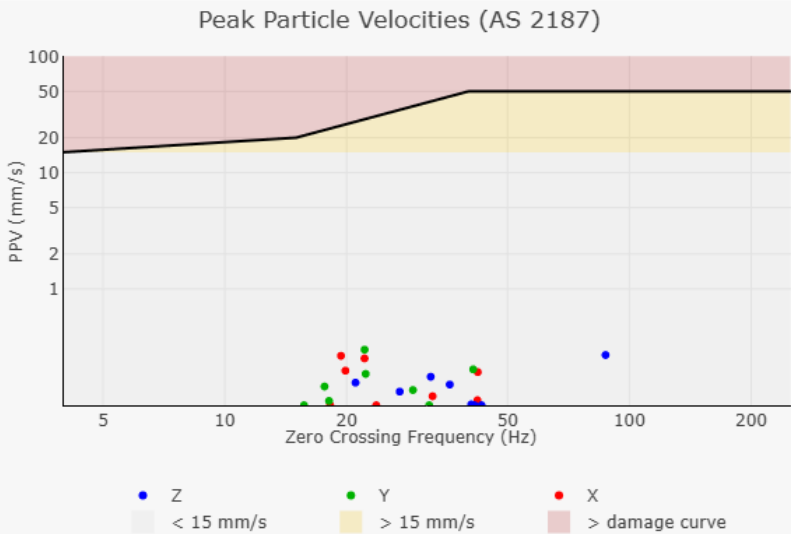
Per-component Peak Particle Velocities (PPV) vs. Zero Crossing Frequencies.  
Line indicates cosmetic damage guidelines  
(residential buildings, Fig. J4.4.2.1, AS 2187.2:2006).
