Ground Vibration Report

| Event Type | Development Blast |
| Event Date | 2026/07/15 |
| Location | Harrier 4240 RAW W |

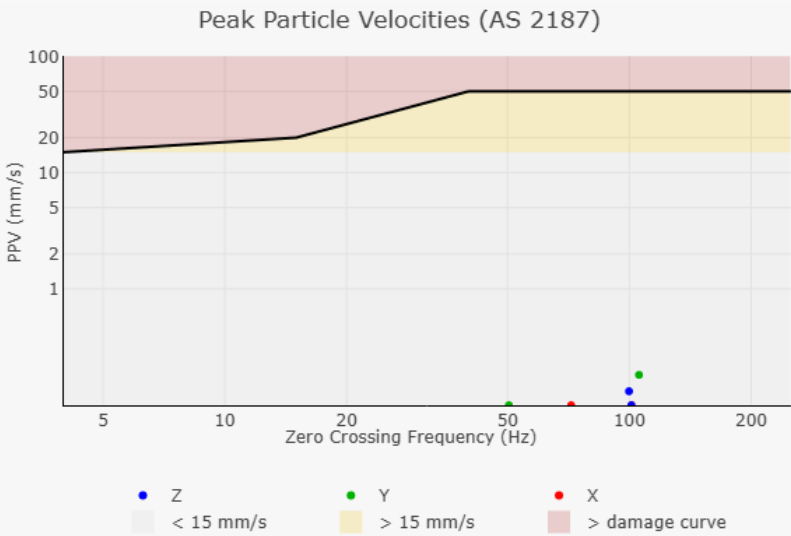
Per-component Peak Particle Velocities (PPV) vs. Zero Crossing Frequencies.  
Line indicates cosmetic damage guidelines  
(residential buildings, Fig. J4.4.2.1, AS 2187.2:2006).
