Ground Vibration Report

Summary

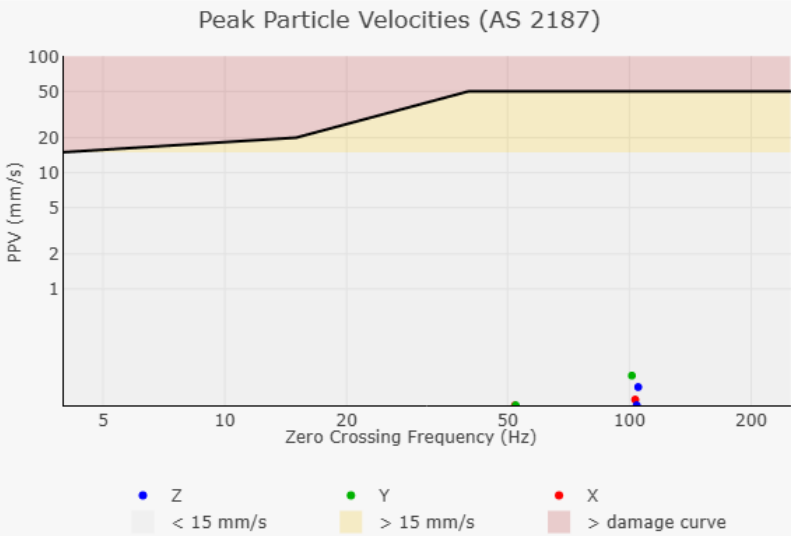
Per-component Peak Particle Velocities (PPV) vs. Zero Crossing Frequencies.  
Line indicates cosmetic damage guidelines  
(residential buildings, Fig. J4.4.2.1, AS 2187.2:2006).
