Ground Vibration Report

Summary

| Notes | PHX 3990 CYG A F1<br>Duration: 3.2s |

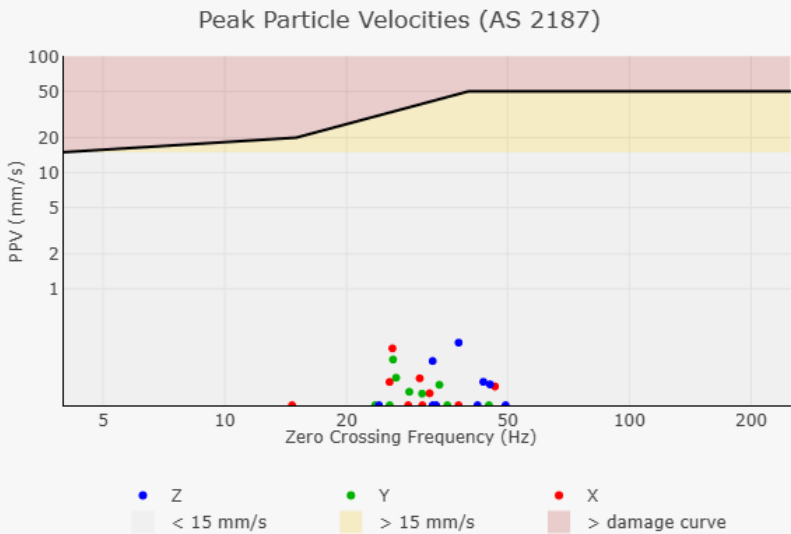
Per-component Peak Particle Velocities (PPV) vs. Zero Crossing Frequencies.  
Line indicates cosmetic damage guidelines  
(residential buildings, Fig. J4.4.2.1, AS 2187.2:2006).
