Ground Vibration Report

Summary

| Location | Phoenix |

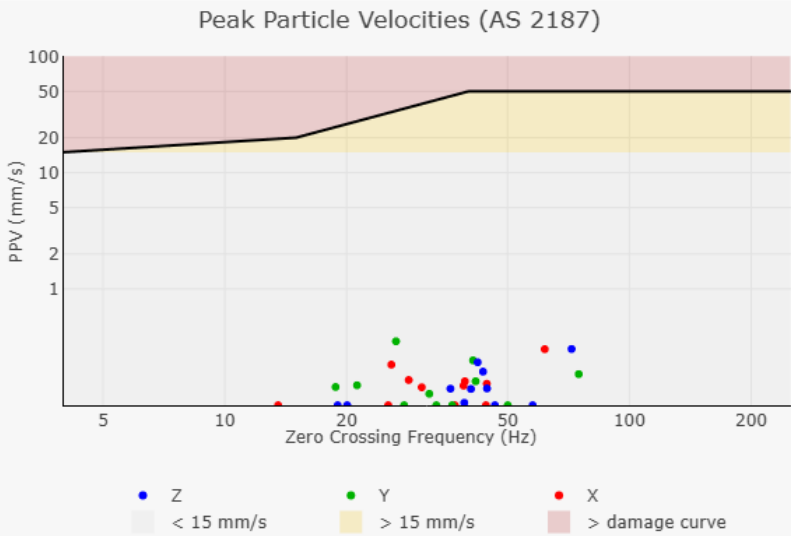
Per-component Peak Particle Velocities (PPV) vs. Zero Crossing Frequencies.  
Line indicates cosmetic damage guidelines  
(residential buildings, Fig. J4.4.2.1, AS 2187.2:2006).
